NVIC 4-85
29 May 1985

NAVIGATION AND VESSEL INSPECTION CIRCULAR NO. 4-85, CHANGES 1 & 2 INCLUDED

Subj: Recalls and Other Corrective Measures for Lifesaving Equipment

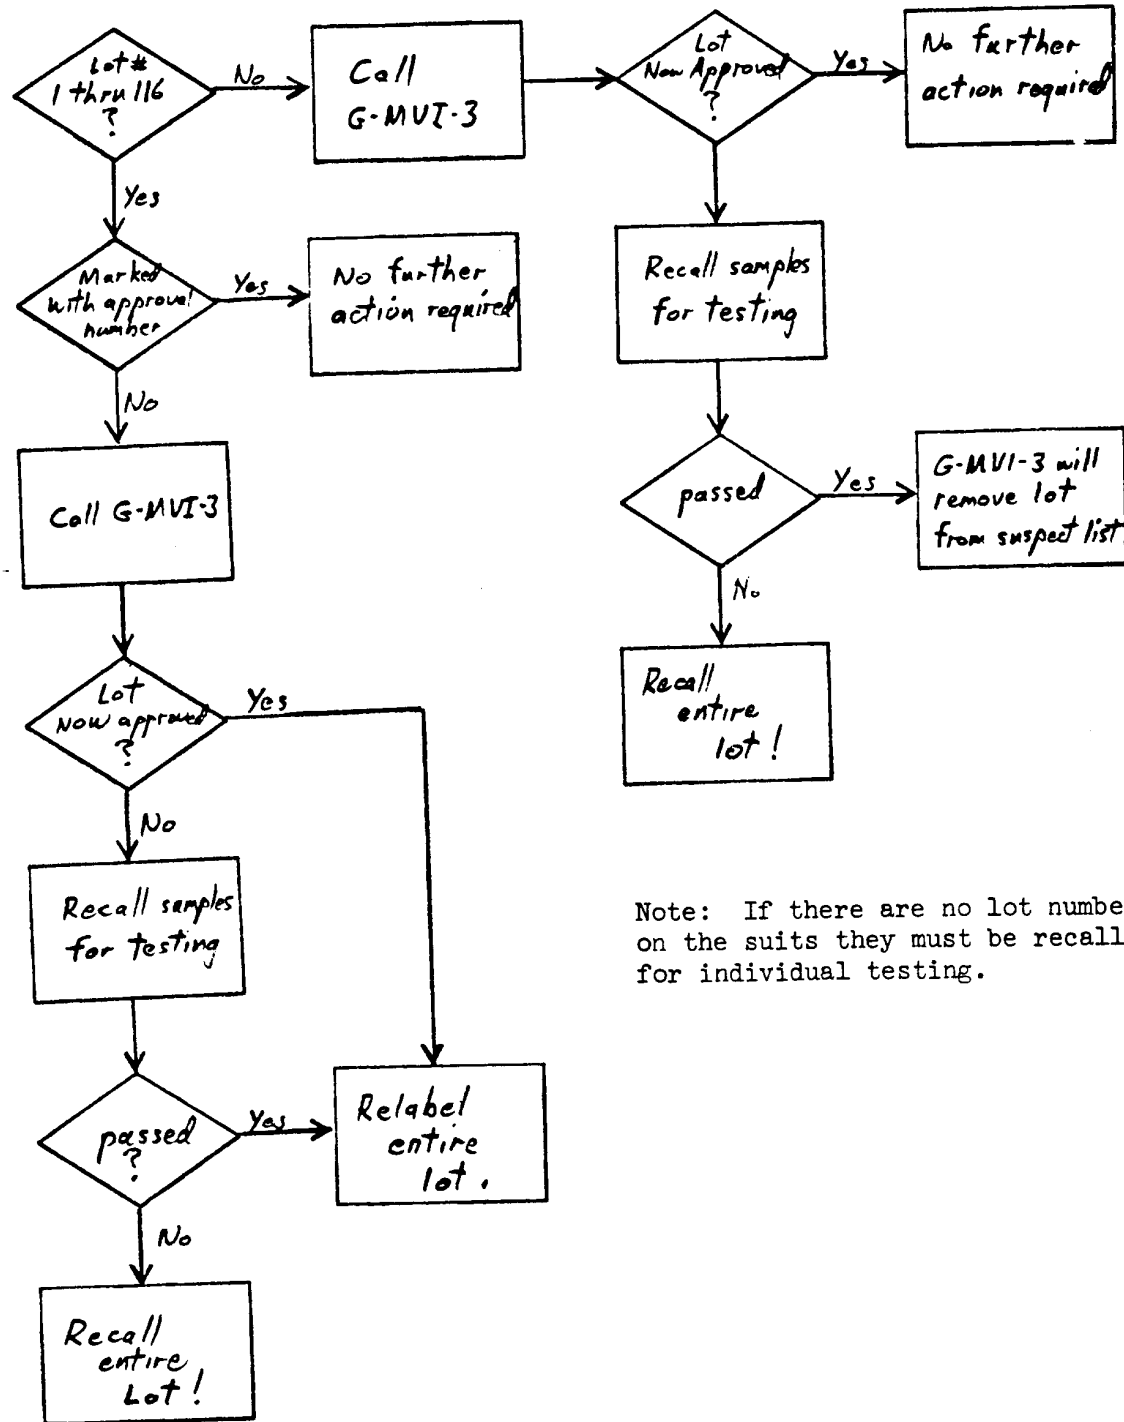
FITZ-WRIGHT SUITS RECALL PROCESS

- a. Fitz-wright exposure suits up to and including Lot 116 were inspected and tested for Coast Guard approval by Warnock Hersey professional Services but were not marked with an approval number on the suit.
- b. Production inspection has since been taken over by Underwriters Laboratories (UL), but suits from lot numbers 117-132, 134, and 136-137 may have been labeled as Coast Guard approved even though they were not inspected and tested at the factory by Warnock Hersey or UL.
- c. Some Fitz-Wright suits have been found to have no lot numbers, and their factory inspection status can not be determined.

- a. Where records in the custody of Underwriters Laboratories indicate that a lot numbered 116 or lower was inspected by Warnock Hersey professional Services, the suits may be relabeled in the presence of a UL inspector.
- b. Where the records indicate that any lot was not inspected by an independent laboratory, representative samples of the lot must be returned to Fitz-Wright for testing by a UL inspector. Fitz-Wright will provide replacements for the samples recalled for testing. After samples of a lot have been tested and inspected, the lot will be approved and all suits of that lot may be relabeled in the presence of a UL inspector.
- c. Any suit which does not bear a lot number can not be considered Coast Guard approved.

- a. Coast Guard inspectors should contact Commandant (G-MVI-3) when suspect suits are encountered, giving lot number of suits, approval number if marked, and identity of vessel and operator. Vessel need not be detained. Commandant (G-MVI-3) can be reached on FTS 426-1444.
- b. Operators may contact Underwriters laboratories to determine the status of suspect suits and arrange for relabeling. If samples from the lot are needed, the operator will be referred to Fitz-Wright to arrange for replacements and shipping of samples. Point of Contact at UL is:

Note: If there are no lot numbers on the suits they must be recalled for individual testing.

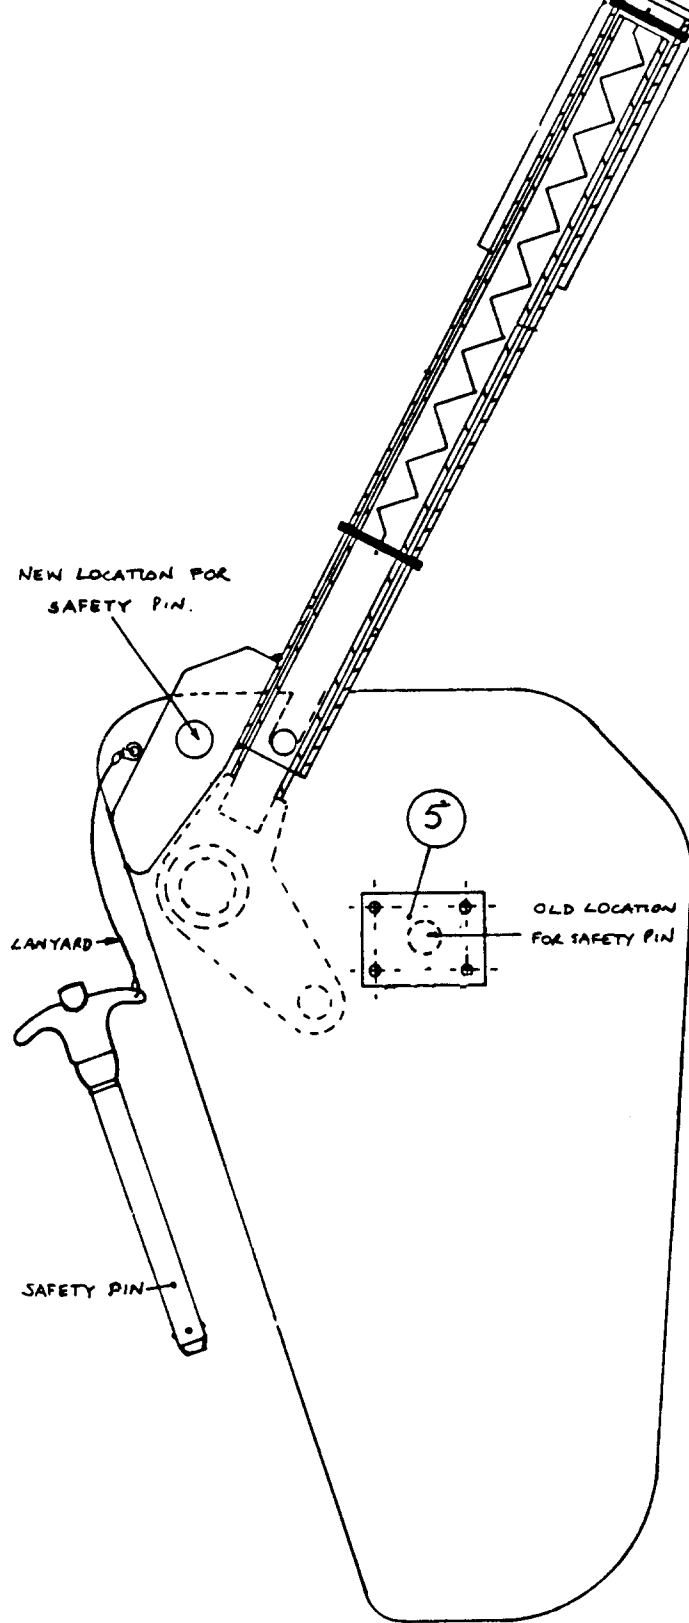
1. PROBLEM. The safety pin on the Titan release gear operating handle used in certain Watercraft America lifeboats, can be inserted before the handle is in the safe, fully closed position. In this condition, the release hooks may appear to be fully closed, but may unexpectedly open when a load is applied.

- a. Titan release gear with approval number 160.033/69/0 must be modified. Titan gear that has been modified can be identified by the cover plate over the old safety pin hole (item 5 on the drawing on the following page), and by the plate added to the release gear handle to accommodate the new safety pin location (see "NEW LOCATION FOR SAFETY PIN" on the drawing).

3. ACTION.
 - a. Vessel and MODU operators having Watercraft America lifeboats equipped with Titan gear having approval number 160.033/69/0 shall make sure the release gear is modified in accordance with Watercraft America drawing SP-201 and Engineering Instruction P-131, both dated 28 October 1985. The Coast Guard Officer in Charge of Marine Inspection shall be notified before the modification work begins. The drawing and instruction may be obtained from:

Watercraft America, Inc.
P.O. Box 1130
Edgewater, FL 32032
(904) 428-5781
Telex: 567415
 - b. Coast Guard inspectors will require modification of Watercraft America Titan release gear with approval number 160.033/69/0 in accordance with the Watercraft America drawing and instruction.

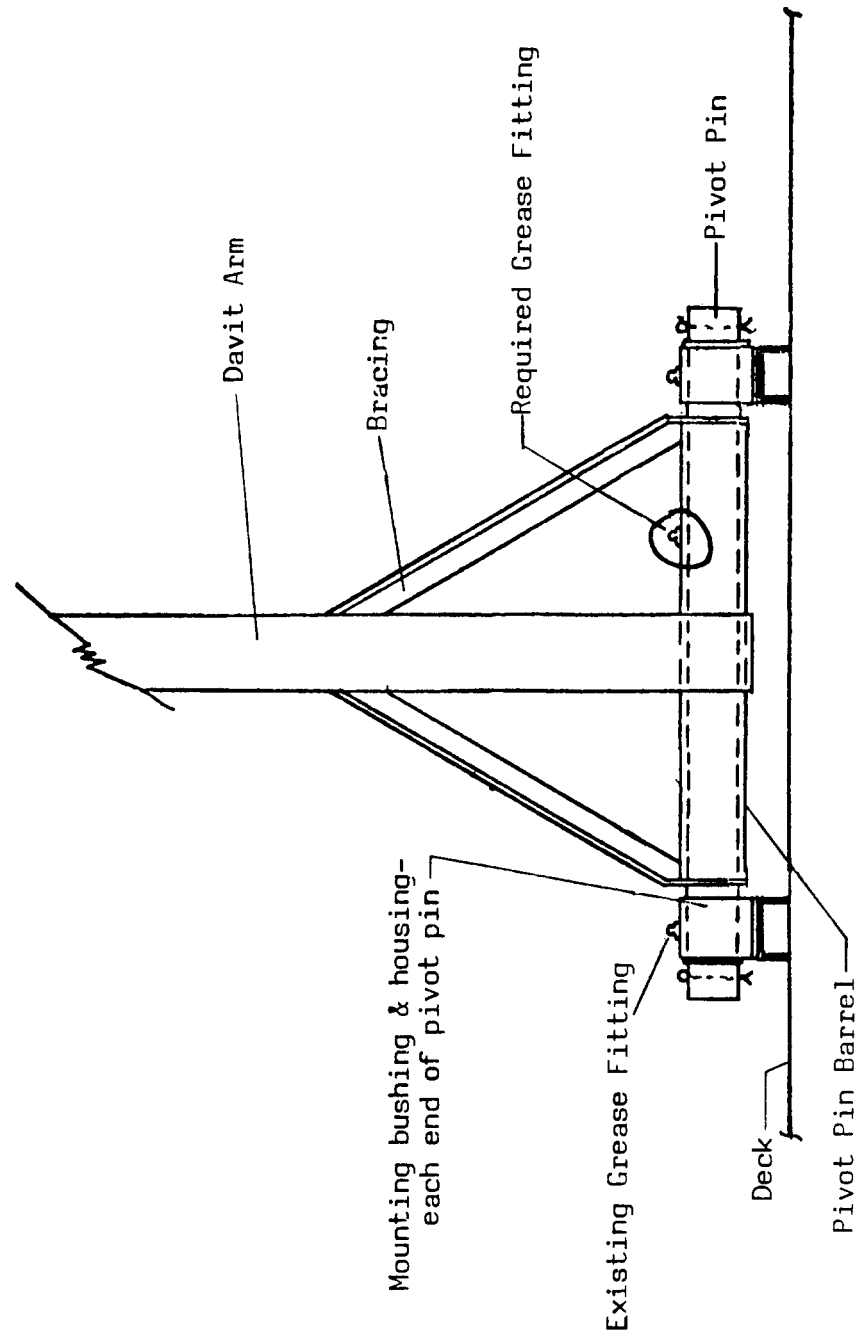
Looking Inboard at Davit Arm Base

1. PROBLEM: The pivot pins of certain mechanical davits arranged as shown in the figure on the following page, are subject to corrosion and seizure, due to water accumulation inside the pivot pin barrel.
2. ACTION: To prevent corrosion and seizure of the pivot pin, the pivot pin barrel should be equipped with a lubrication fitting as shown in the figure. Grease should be applied to this fitting regularly to exclude accumulated water in the barrel in order to permit easy operation of the davit.
 - a. Modification of mechanical davits to add this lubrication fitting is authorized. The Coast Guard Officer in Charge of Marine Inspection shall be notified before the modification work begins.
 - b. Coast Guard inspectors will require the addition of lubrication fittings to the pivot pins of mechanical davits where it is evident that water accumulation and corrosion is a problem.

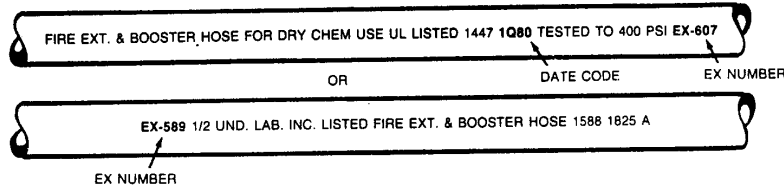
**ILLUSTRATION 1**

1. If extinguisher has a yellow "Inspected" sticker on the front, go to step 9.
2. Find U.L. Listing information printed on hose (either white print or molded on hose cover). (See illustration 1 below.)

3. If there is no printing, or printing is unreadable, replace hose assembly and destroy old hose.
4. Refer to **EX** number on hose, if it is **NOT** EX-607 or EX-589, hose is good, do **NOT** replace.
5. If EX-607
 ↓
EX-607
 6. If EX-607, refer to date code (Example 1Q80 means 1st Quarter 1980)
 7. If Date Code is between 1Q77 and 4Q83, replace hose assembly, destroy old hose. If dated **BEFORE** 1Q77, hose is good, go to step 9.
- OR If EX-589
 ↓
EX-589
 6. If unit is **NOT** Ansul Model 20 Hand Portable, hose assembly is good, go to step 9. (To identify unit, refer to maintenance nameplate on back of extinguisher.)

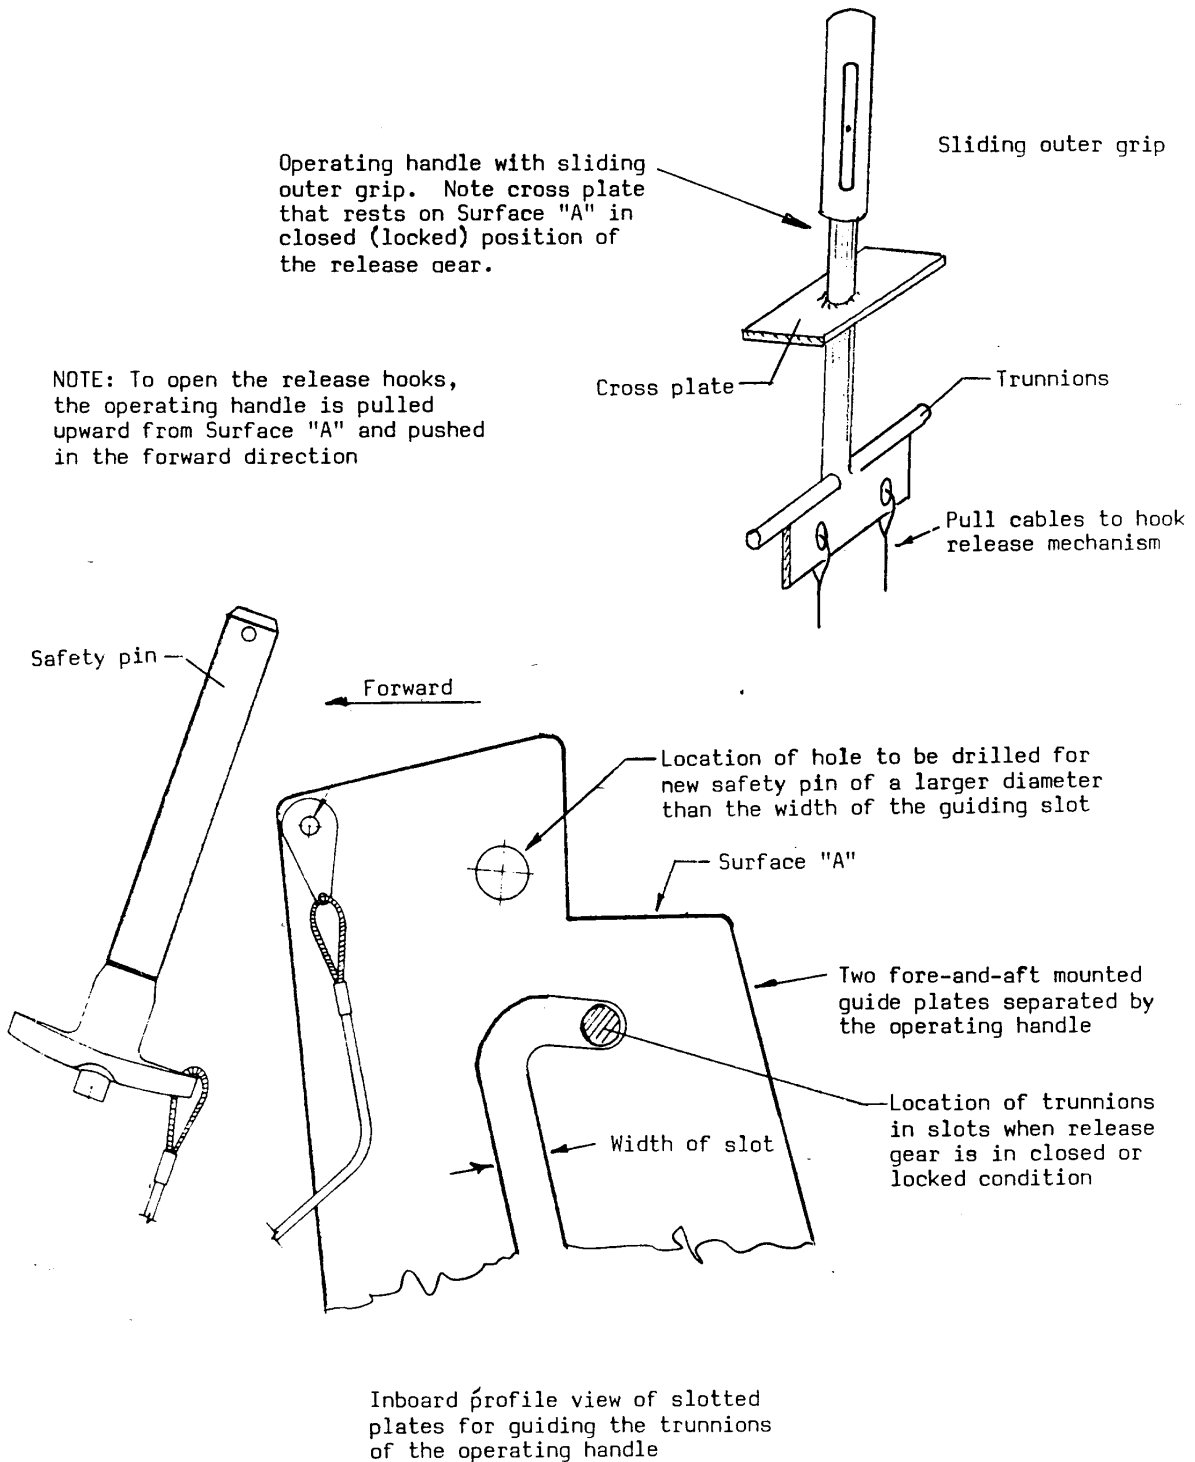
1. PROBLEM. The safety pin for the Viking release gear operating handle used in certain Watercraft America lifeboats, can be accidentally inserted into the slot for the release handle trunnion, rather than the hole intended for the safety pin. If this is done, the release gear is not in a safe condition.

2. DISCUSSION. Watercraft America, Inc. has developed a modification to prevent the accidental insertion of the safety pin before the handle is in the fully closed position. Viking release gear with approval numbers 160.033/66/0, 160.033/66/1, and 160.033/66/2 must be modified by drilling out the safety pin hole and replacing the original safety pin with a larger one.

3. ACTION.
 - a. Vessel and MODU operators having Watercraft America lifeboats equipped with Viking gear having approval numbers 160.033/66/0, 160.033/66/1, or 160.033/66/2 shall make sure the release gear is modified in accordance with Watercraft America drawing 5P204 dated May 2, 1986. The Coast Guard Officer in Charge of Marine Inspection shall be notified before the modification work begins. The drawing and instruction may be obtained from:

Watercraft America, Inc.
P.O. Box 1130
Edgewater, FL 32032
(904) 428-5781
Telex: 567415
 - b. Coast Guard inspectors will require modification of Watercraft America Viking release gear with approval numbers 160.033/66/0, 160.033/66/1, or 160.033/66/2 in accordance with the Watercraft America drawing and instruction.

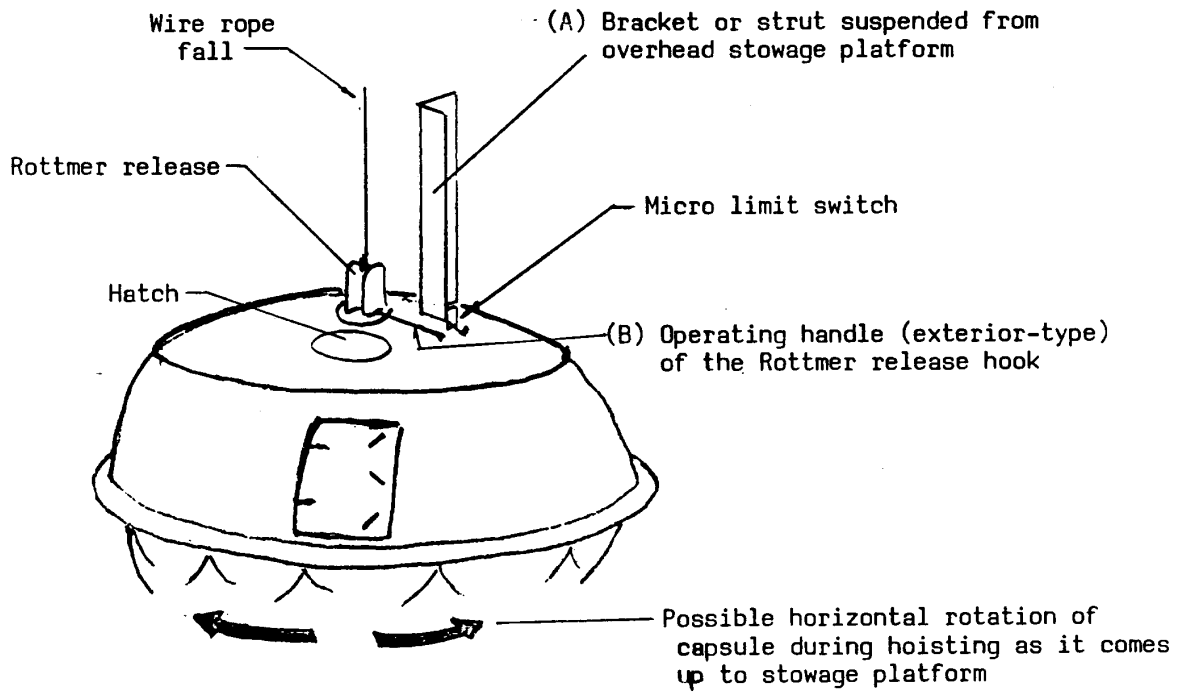
2. DISCUSSION: The unauthorized modifications may appear to be almost identical to the brackets that hold the limit switches which are part of the approved launching system. If brackets are added and not carefully located, they can engage the cable and sector operating mechanism on those capsules equipped with Rottmer type hooks. This has happened on two separate occasions, resulting in the accidental opening of the hook and dropping of the capsule. Any person on board the capsule is at risk of being seriously injured.

NOTE: The above arrangement has the danger of letting the operating handle(B) of the Rottmer release to push against the bracket(A) suspended from under the stowage platform. This could result from the horizontal rotation of the capsule as it comes up into the stowed position. This unintended interference is a potential hazard because of the chance that the operating handle(B) could be moved from its locked position, thus permitting the capsule to drop free of the wire rope fall.

3. ACTION: Servicing personnel and Coast Guard inspectors should make sure -that any brackets on Whittaker capsule launching devices are part of the approved system or are approved modifications. Generally, the only brackets coming close to the surface of the capsule should be those holding the limit switches which prevent the capsule from being winched into the stops under motor power. Any others should be considered suspect, unless the owner or operator can show that they are approved additions. Any unauthorized modifications of this type must be removed. Questions on whether or not such brackets are approved can be answered by the manufacturer:
